Manhole Inspection Summary

Manhole # S09OO_026MH

Insp Date: **8/9/07 7:36 AM**

Location Address: **DENISON AVE**

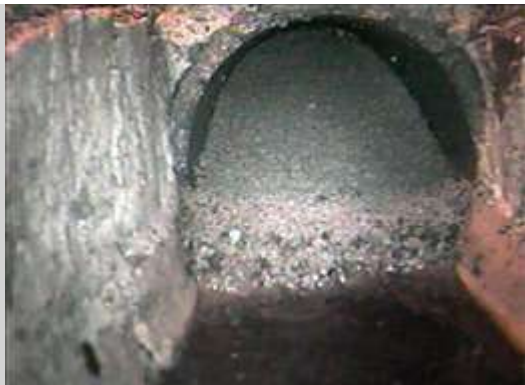
6 O'Clock Inflow

8 in. Circular Gravity Sewer
Pipe In @ 6 O'Clock

Pipe Height: (in.) Direct
Pipe Material: **Clay** ☐ Pipe Lined
Invert Depth: **6.50** (ft.) Flow Characteristics: **None**
Deposits: ☒ **None** ☐ Mud ☐ Sludge ☐ **Debris** ☐ Grease
Silt Depth: (in.) Deposits Extent:
Infiltration: **None** Pipe Seal Cond: **Sound**
